## VERY SERIOUS MARINE CASUALTY

Injury of three rescue boat crew members, onboard the container vessel DORIKOS on 27 August 2015, due to breakage of fall wire whilst the rescue boat was lowered.

Report date: 03 June 2016

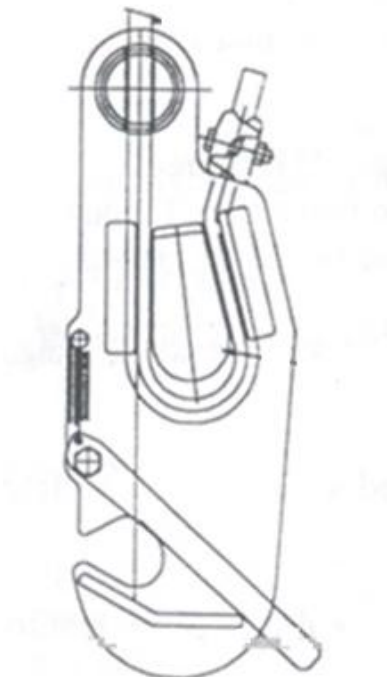
The fall wire connecting hook was made by Harding type RH 1.5. The assembly of one free end of the fall wire on the winch drum is done by fixing it by a wire lock on the drum. The fixing of the other free end of the fall wire at the hook is done with the use of a wedge lock device after the wire is passed through the hook housing passage as indicated herebelow.

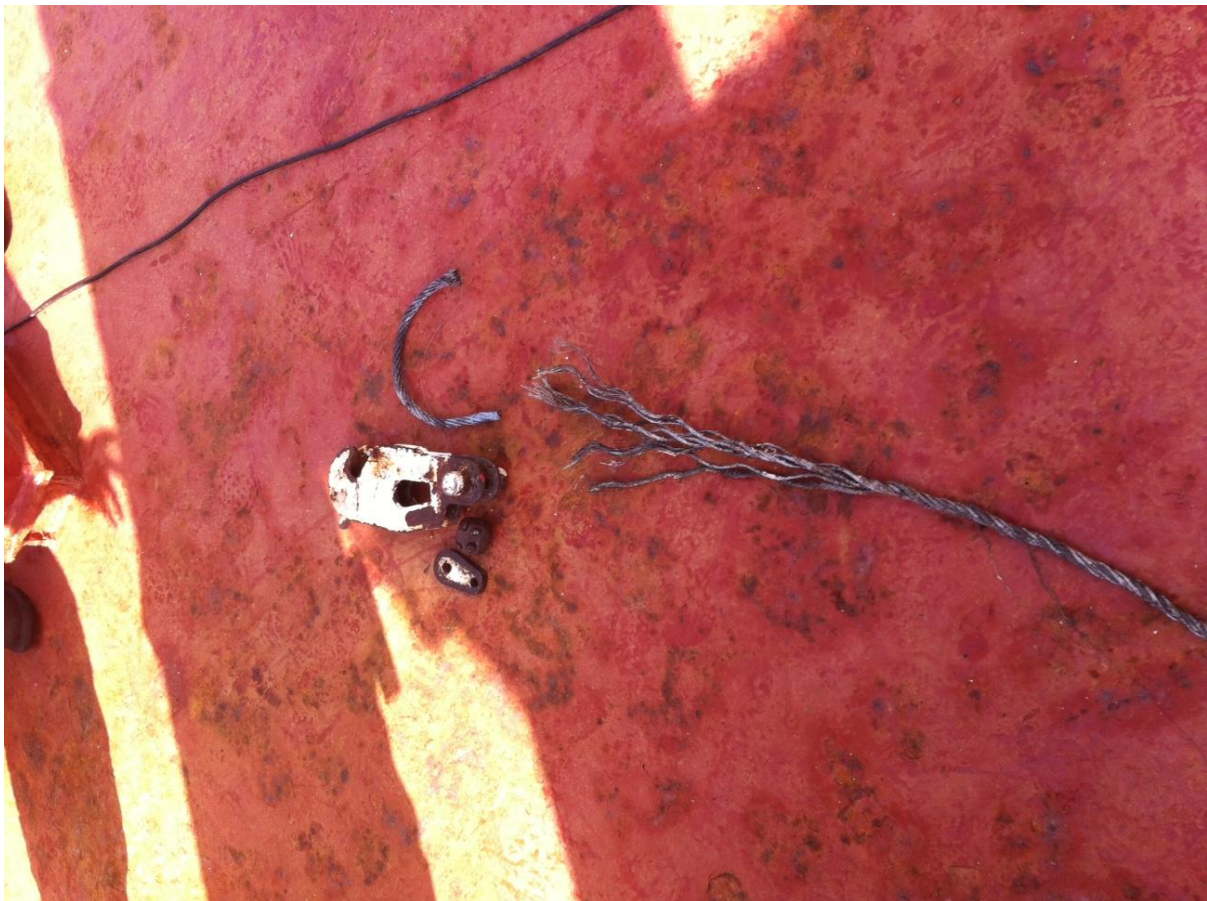
The fall wire was found to have failed at a position of approximately 0.42 m from the end of the wire.

The 0.42 m section of the wire had been disconnected from the housing of the hook and therefore the way of its assembly at the time of the incident was not readily obvious. When it was installed within the housing of the hook, the broken end of the wire appeared to be outside of the hook as indicated in the blow photo.

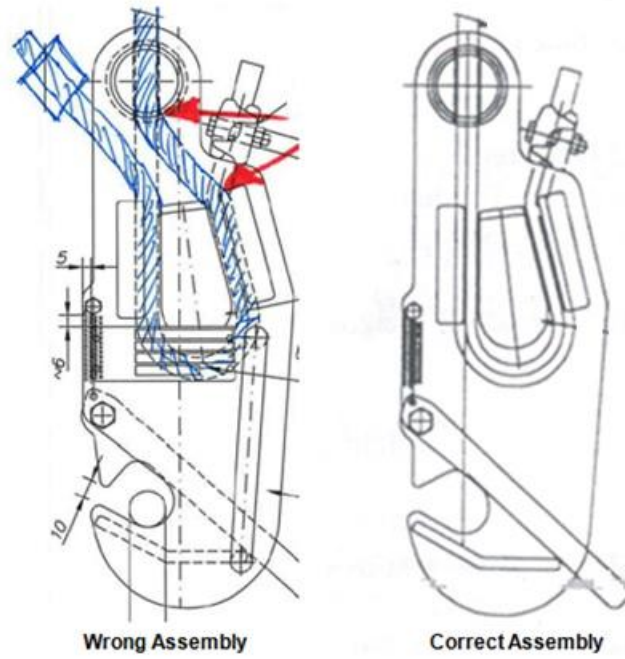
Subsequent investigation however was made, on the request of the ship’s Management Company, by the hook Makers’ technical department, which revealed that the wire had been wrongly assembled during last renewal and its breakage position was within the hook housing as shown below:

Evidently the failure of the fall wire occurred as a result of incorrect assembly of the wire end to the hook. The incorrectly assembled wire end, was thereafter subject to mechanical stresses on the wire outer surface in way of bending within the hook housing, leading to its failure.

A circular or safety alert to be sent by the Management Company to all vessels of its fleet within 3 months containing brief description of the accident, stating the lessons learned from the accident, and stressing the importance of the correct assembly of wires to hooks, blocks etc.

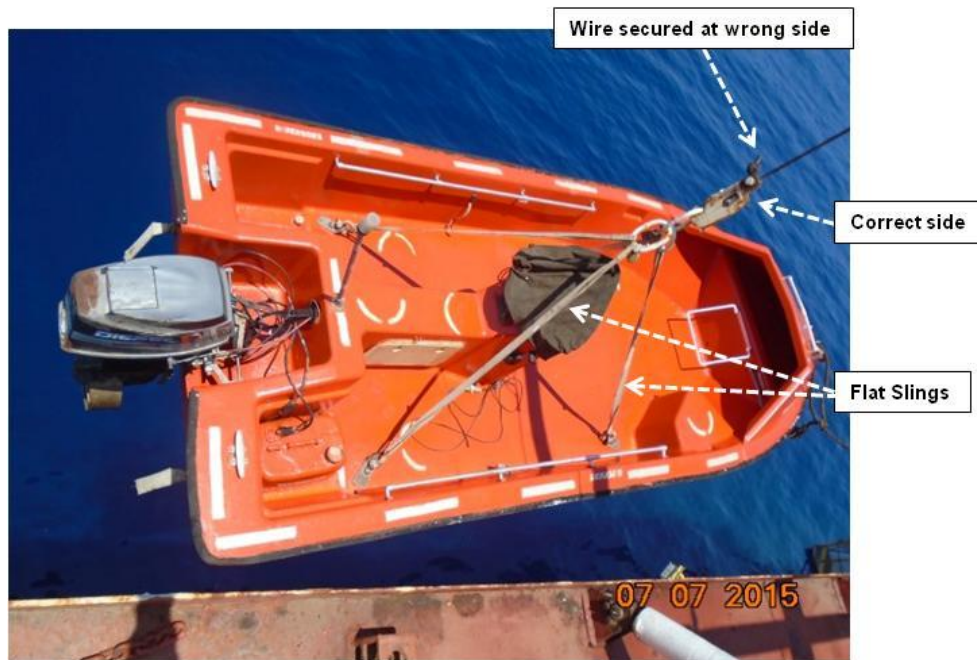
The Makers came to this conclusion when their technical team observed on a photo taken by the crew on the previous drill done on 7<sup>th</sup> July 2015, that the secured end of the wire at the hook was at the wrong side of the hook. The relevant photo is reproduced herebelow for ready reference.
