REPUBLIC OF CYPRUS
MARINE ACCIDENT AND INCIDENT
INVESTIGATION COMMITTEE

[Investigation Report No: 115/2014]

Very Serious Marine Casualty

Collision between the Bulk Carrier “Panamax Blessing” and the General Cargo Ship “Harmony Rise”, off the Korean Coast - Japan sea, on the 10th of July, 2013.

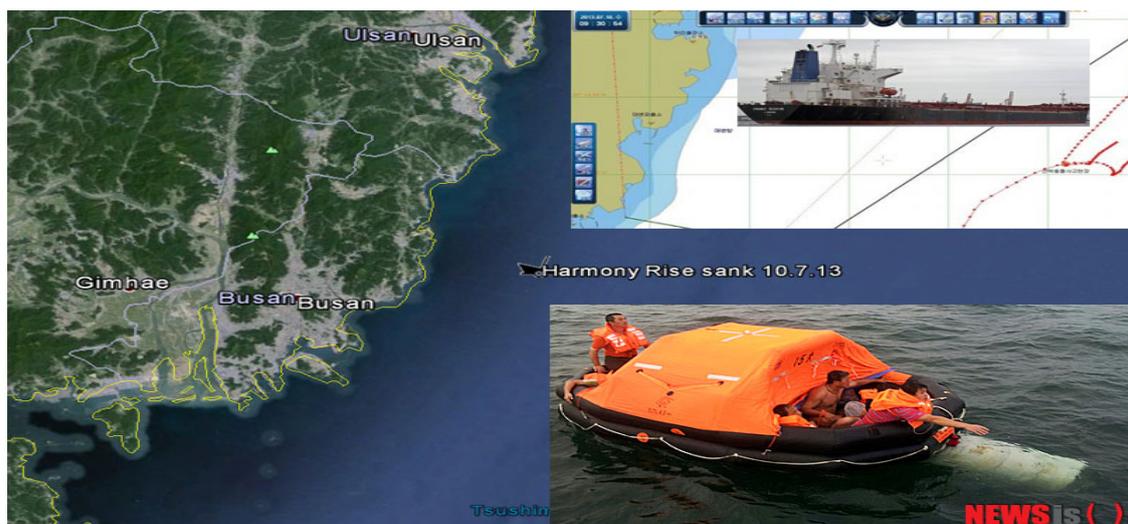
M/V “HARMONY RISE” all 12 crew members, who fell into the sea after the collision, and subsequently boarded on theirs’ ship Life-Raft which opened automatically, were safely rescued by Ulsan Coast Guard’s boats.

Figure 2: M/V “HARMONY RISE” 12 crew members, in L/R

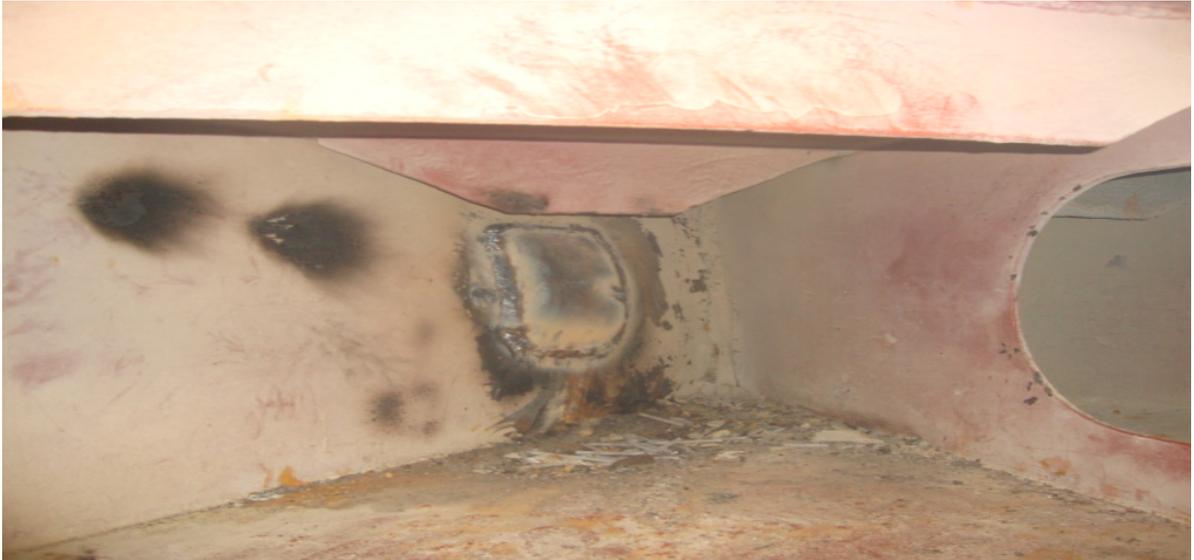
“PANAMAX BLESSING”: Sustained a hole on the upper side of the Fore Peak Tank
Bending of stbd side forward stanchions / rails

Figure 3: Panamax Blessing damage, repaired(from within Fore Peak Tank)

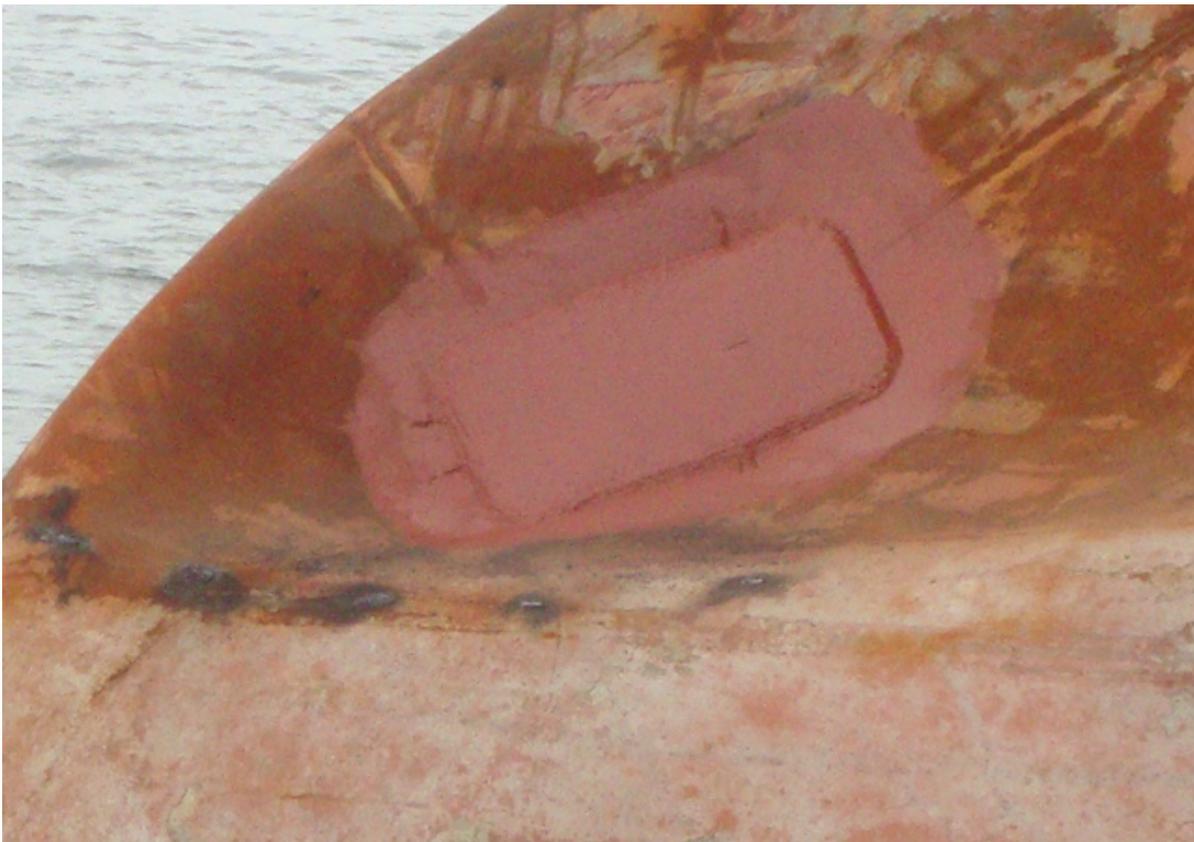
“Panamax Blessing” sustained a hole on the upper side of its bulbous bow.

Figure 4: Panamax Blessing damage, repaired(on bulbous bow)

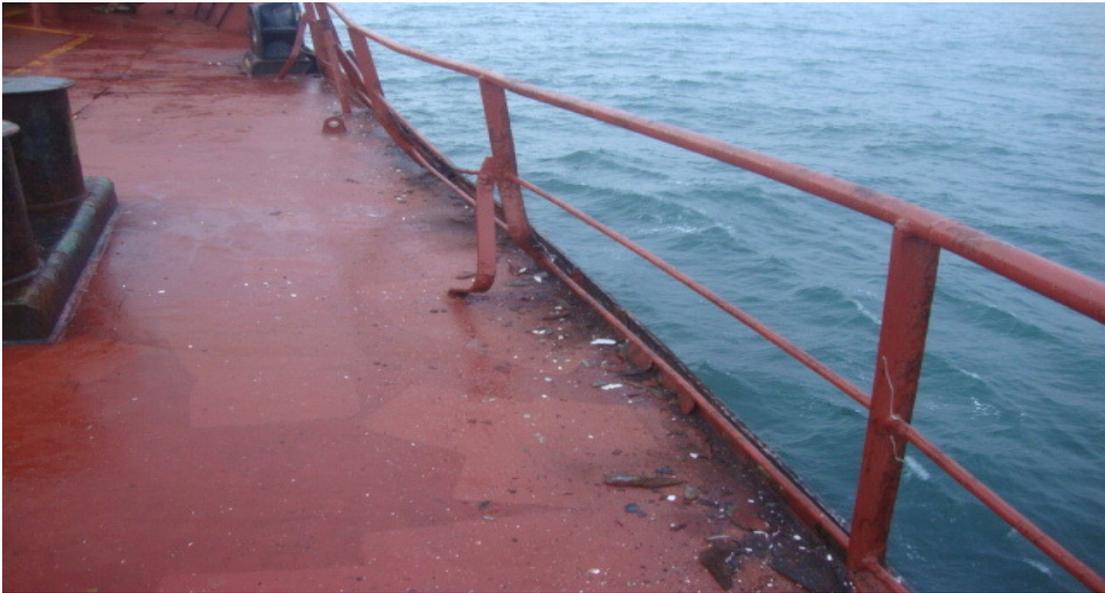
Figure 5: Panamax Blessing damage on starboard side

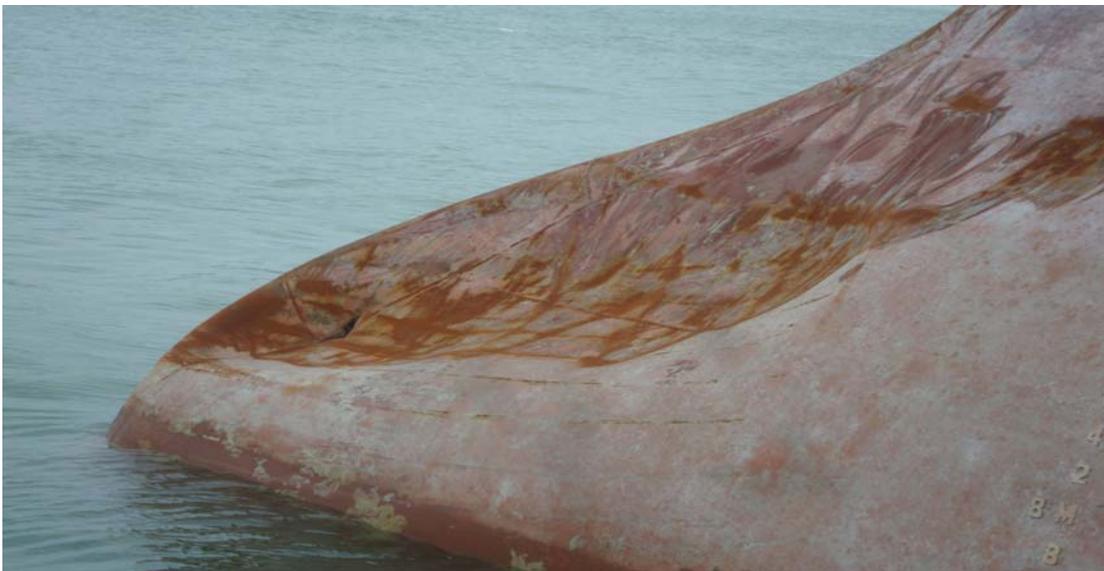
Figure 6: Panamax Blessing damage on bulbous bow

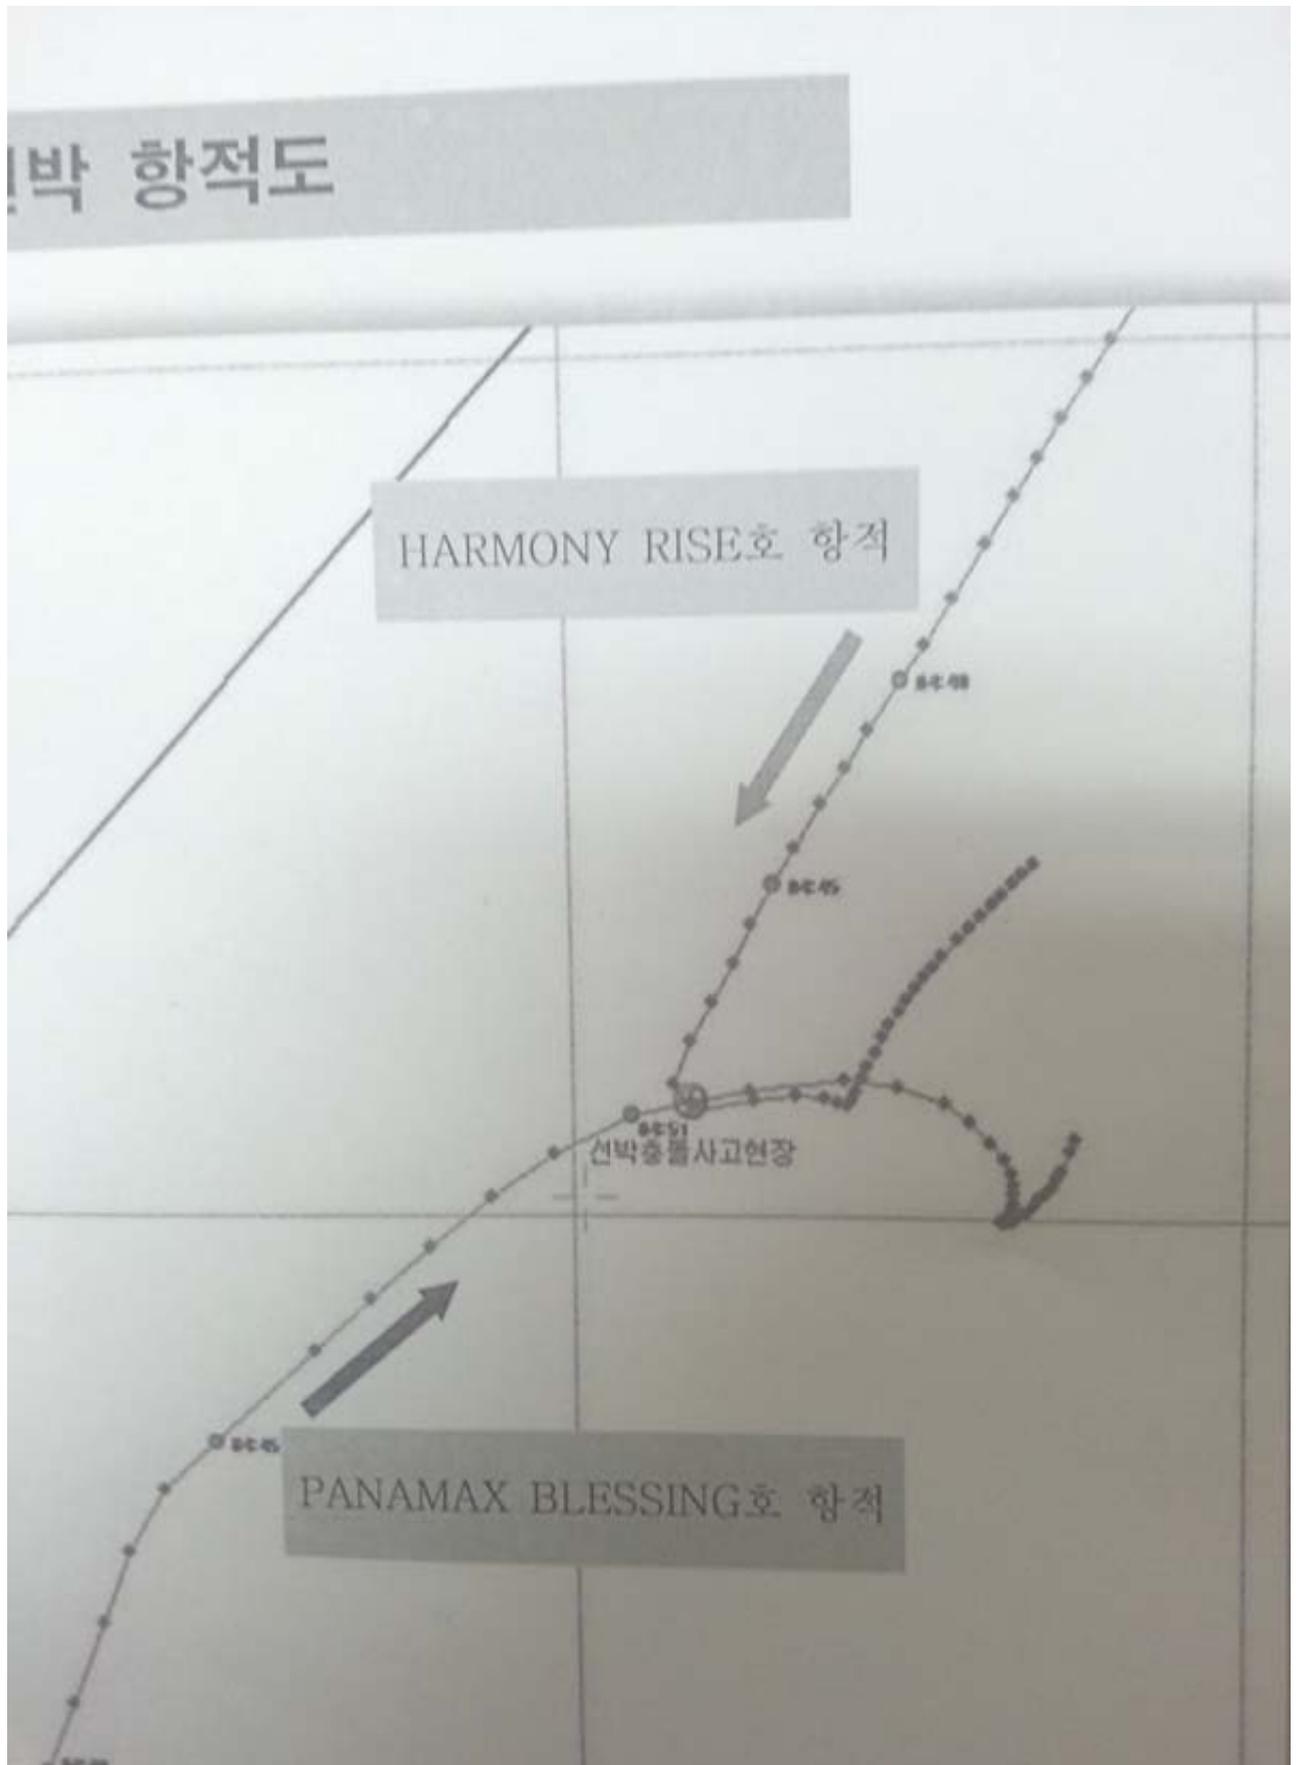
Figure 7: Data from Ulsan VTS

Data from the Ulsan VTS (**Figure 7**) was very helpful to reconstruct the course of events.
