REPUBLIC OF CYPRUS
MARINE ACCIDENT AND INCIDENT
INVESTIGATION COMMITTEE

[Investigation Report No: 115/2014]

Very Serious Marine Casualty

Collision between the Bulk Carrier “Panamax Blessing” and the General Cargo Ship “Harmony Rise”, off the Korean Coast - Japan sea, on the 10th of July, 2013.

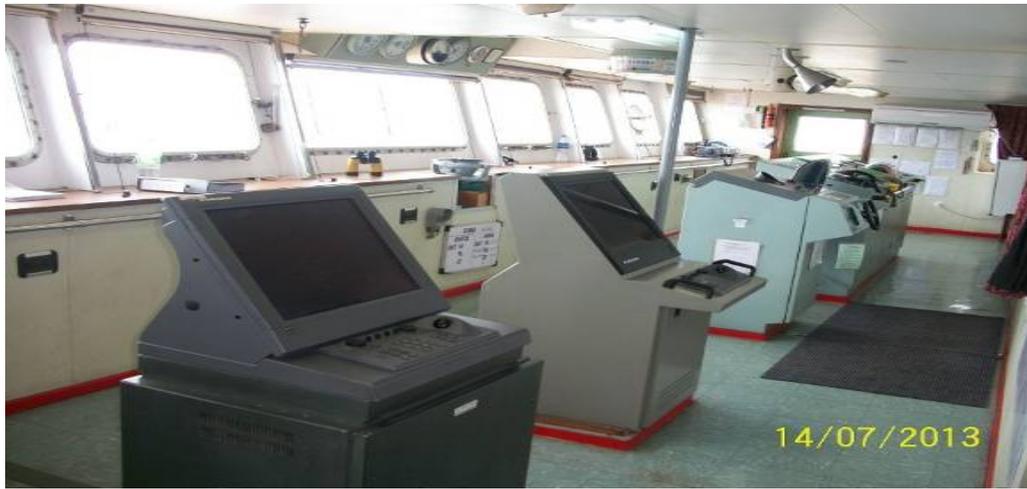
Figure 8: The Wheelhouse of “Panamax Blessing”

“Panamax Blessing” had valid certificates and the maintenance records indicated that was maintained in accordance with existing regulations and approved procedures.

There was no evidence of any defect or malfunction that could have contributed to the accident.
